MEMORANDUM

Project: 150557-01.01

Re: San Jacinto River Waste Pits TCRA Armored Cap Probing and Maintenance

Completion Report

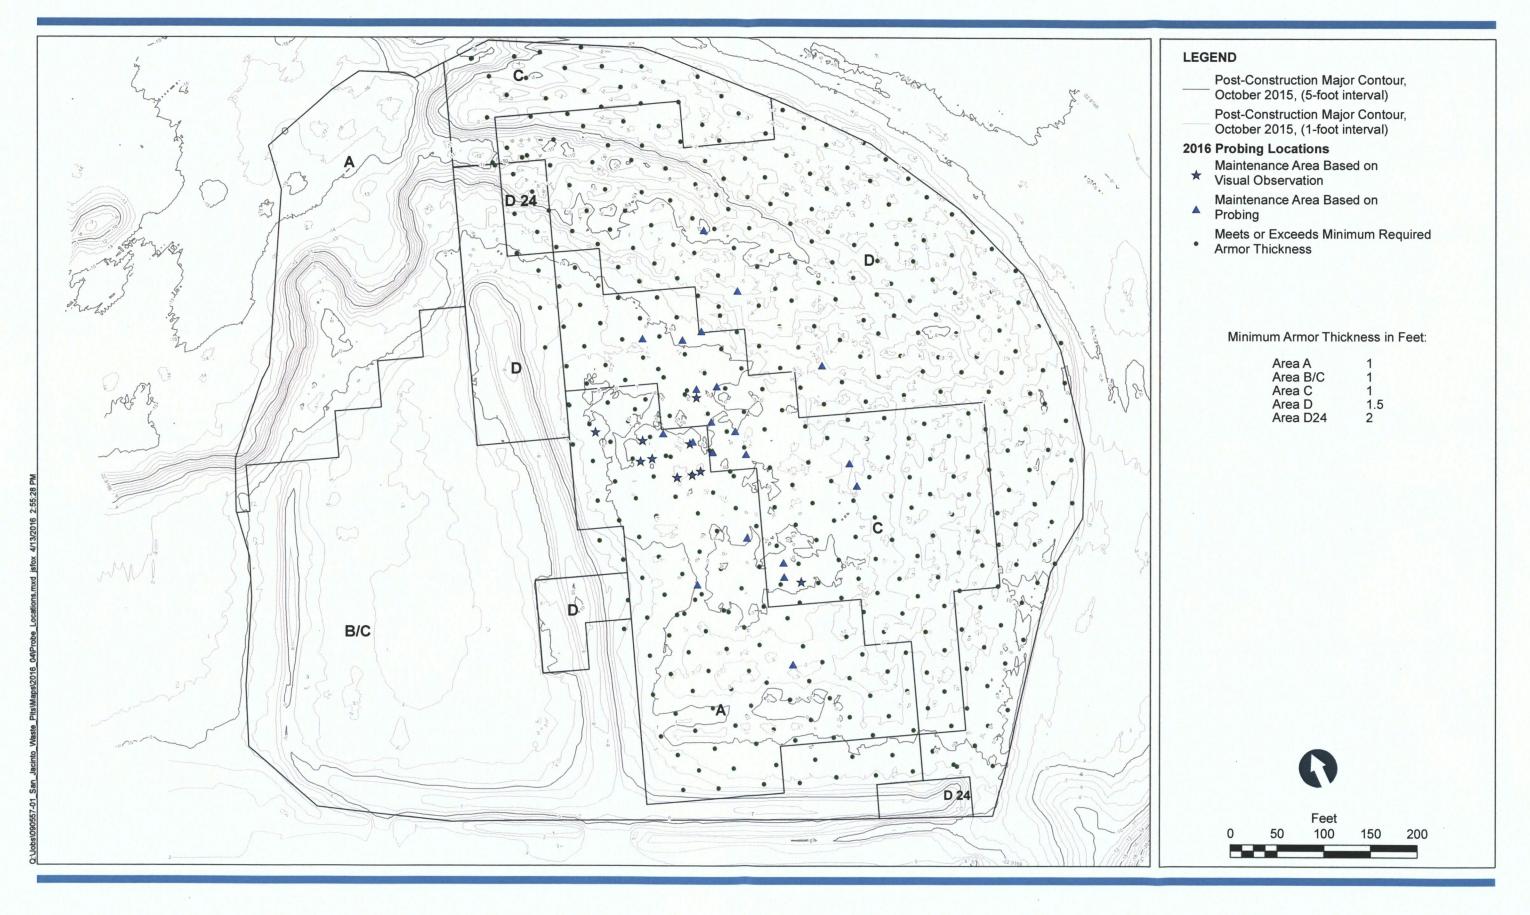
Figure 1 - Armored Cap Probing and Maintenance Locations

Taking advantage of exceptionally low tides in the area of the armored cap, engineering staff from Anchor QEA, on behalf of the Respondents, were able to observe large portions of the cap in the Eastern Cell and conduct a visual inspection on February 24, 2016. The inspection included many areas that are normally under water. During this inspection, five small areas of exposed geotextile (from 1 foot \times 1 foot up to 2 feet \times 3 feet) were observed, and their locations were recorded with photographs and in the field notes. These locations, along with the areas identified during subsequent probing and low-tide investigation activities, are shown on Figure 1.

The probing and second low-tide event visual inspection on March 19, 2016, identified approximately eight additional areas of exposed geotextile and/or insufficient armor rock thickness within the Eastern Cell. These areas were recorded in the field utilizing a DGPS

unit and marked for maintenance. The areas varied in size from 1 to 50 square feet, with more than half of the areas being less than 5 square feet. These areas are shown on Figure 1.

Maintenance activities began each day with a tailgate safety meeting for all personnel. See the Daily Reports (Attachment 1) for a complete list of personnel on-site and activities performed each day. The maintenance contractor utilized a small pontoon barge to transport the armor stone from the location on the shoreline where it was temporarily stockpiled to each of the maintenance locations. A skid steer was used to transfer the armor stone from the temporary on-site stockpile to the pontoon barge. After the pontoon barge was loaded with armor stone, the stone was floated to the respective maintenance locations and placed in the prescribed areas until sufficient cap thickness was achieved. The maintenance area locations are shown on Figure 1. Each location was then reprobed to confirm coverage of the exposed geotextile and that a minimum cap thickness was present of at least 1 foot of armor stone in Areas A and C of the Eastern Cell and at least 1.5 feet of armor stone in Area D of the Eastern Cell.

The second maintenance event addressed the areas identified by the March 16–19 and March 21, 2016, probing and low-tide inspection. It began on March 22, 2016, and was conducted in accordance with the Armored Cap Maintenance Work Plan submitted to USEPA and approved on March 21, 2016 (Attachments 5 and 6). During this maintenance event, additional areas of exposed geotextile and/or areas of insufficient armor rock thickness were identified and reported to the USEPA personnel on-site. Verbal approval was obtained from USEPA to add these locations to the ongoing maintenance activities. All maintenance was completed as approved by placing stone in the maintenance areas until sufficient cap thickness could be confirmed. Each area was then reprobed to confirm adequate cap thickness had been achieved. The maintenance area locations were recorded using a DGPS survey unit. The blue dots on Figure 1 illustrate the areas where additional rock was placed during the maintenance event. Approximately 170 square feet of the cap area in the Eastern Cell (consisting of a total of 369,000 square feet) were serviced during the second maintenance event. Daily reports of this maintenance event are included in Attachment 1.

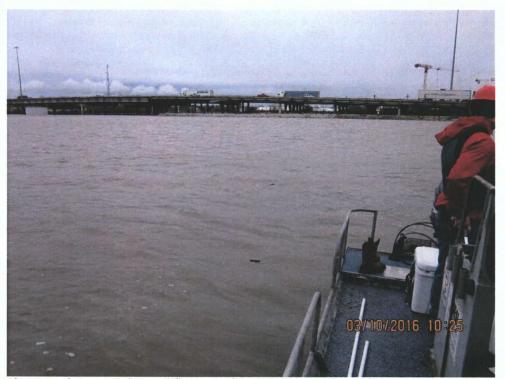
Photograph 2 – Weights and floats marking locations without 1' armor rock above the geotextile layer (view southeast).

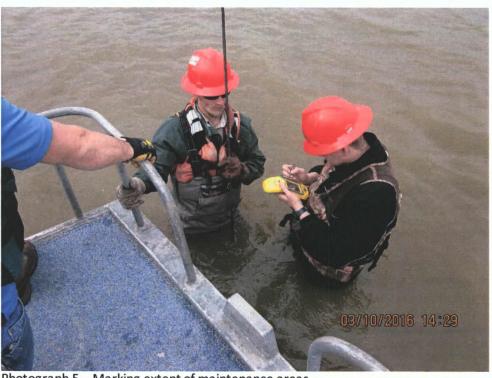
Photograph 5 – Marking extent of maintenance areas.

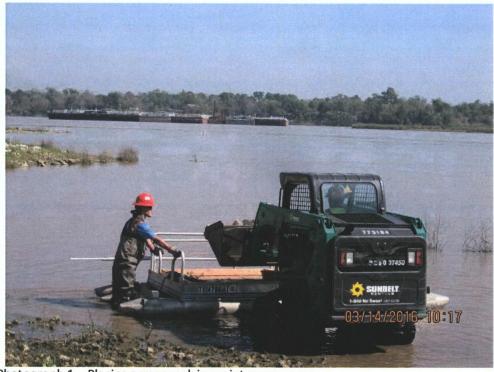
Photograph 1 – Placing armor rock in maintenance area.

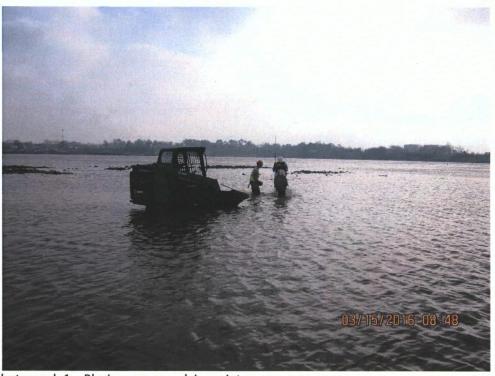
Photograph 1 – Placing armor rock in maintenance area.

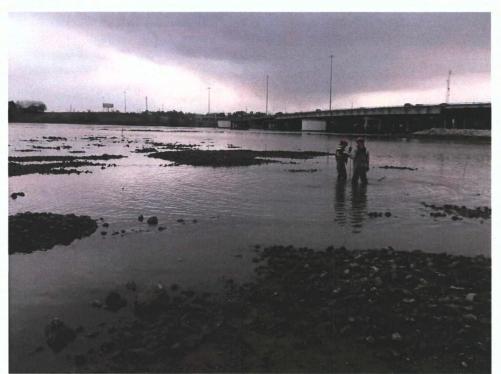
Photograph 3 – Low tide visual inspection of location of skid steer.

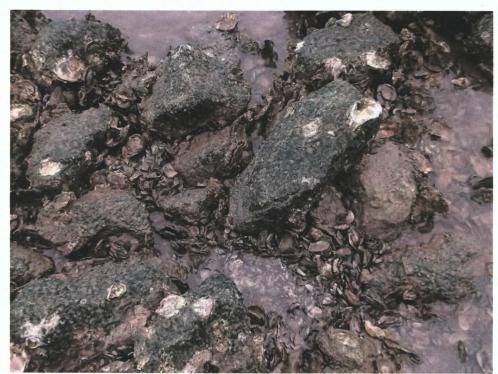
Photograph 3 – View of shellfish growth on perimeter of East Cell.

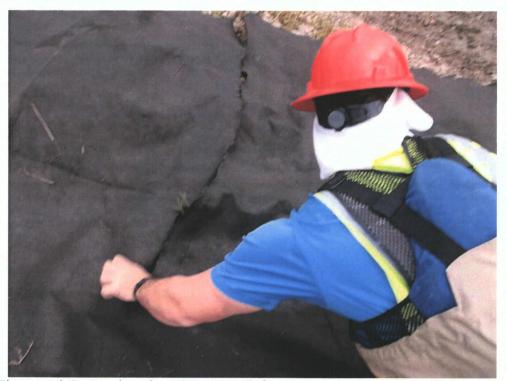
Photograph 2 – Benchmark cutting geotextile for cap maintenance.

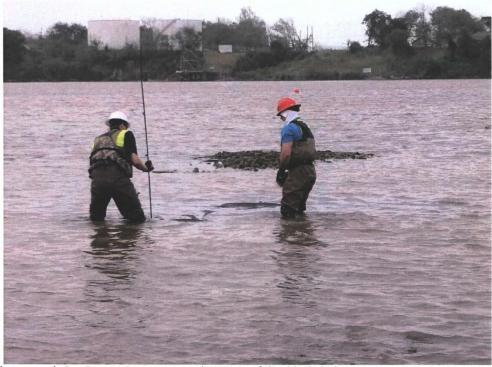
Photograph 3 – Cap maintenance at location of disabled skid steer area.

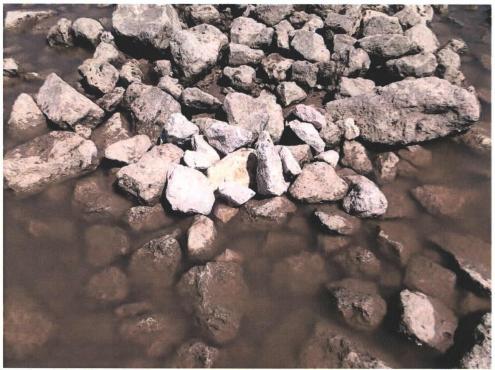
Photograph 3 – View of cap repair location at low tide.

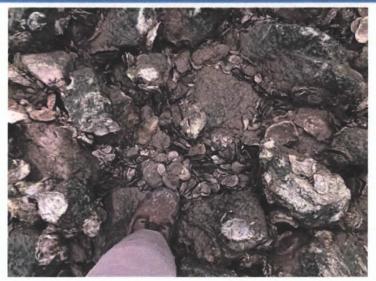
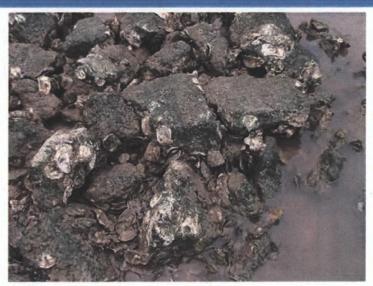
During a low-tide visual inspection of the Eastern Cell that was conducted on Saturday, March 19, 2016, the voids between individual stones in the armor rock were observed to be filled with shells, shell hash, and shell debris, making penetration through this layer difficult or impossible. Photographs providing examples of typical shell and debris encountered are shown in Photographs 1 through 4 in Attachment 4. Similarly, areas of the armored cap consisting of Type A rock were difficult to penetrate due to the cemented nature of the mixture of fine aggregates and recycled concrete used in these areas. Photographs of the cement-like structure described above are shown on Photographs 5 through 8 in Attachment 4. Additional visual and probing inspections, and additional observations made by digging into the armored cap with a shovel at a subset of locations indicated where there was either significant biological growth and/or natural cementation within the cap and that there has not been disturbance of the armor material. Daily reports of this probing and low-tide visual inspection event are included in Attachment 1.

Photograph 01 Shell hash and debris in D rock voids—March 19, 2019

Photograph 02 Shell hash and debris in D rock voids—March 19, 2016

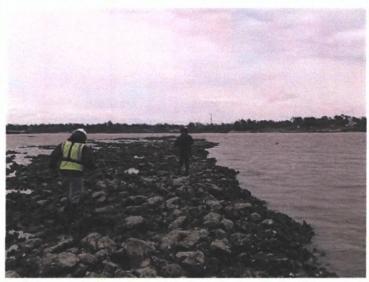
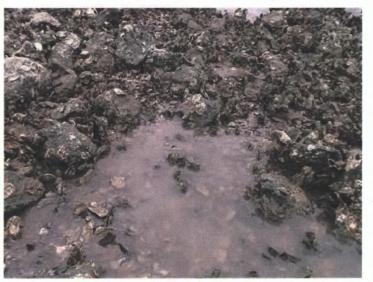
Photograph 03 Extensive shell growth in D rock areas—March 19, 2016

Photograph 04 Extensive shell growth in D rock areas—March 19, 2016

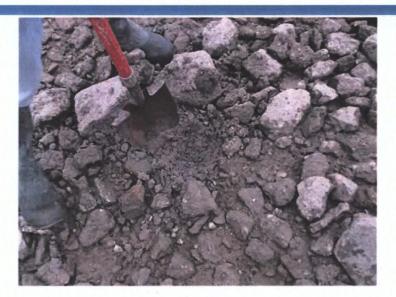
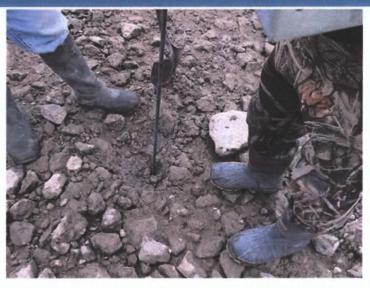
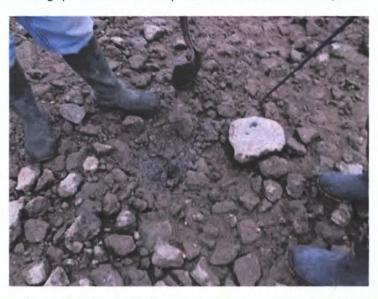
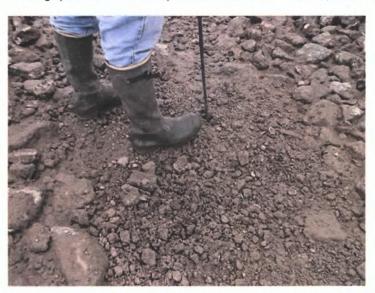
Photograph 05 Cement-like compaction in A rock areas—March 19, 2016

Photograph 06 Cement-like compaction in A rock areas—March 19, 2016

Photograph 07 Cement-like compaction in A rock areas—March 19, 2016

Photograph 08 Cement-like compaction in A rock areas—March 19, 2016
